November 15, 2016 – Presentation and discussion with members of the Commercial Fisheries Center

# CSO Abatement Project: 3 Phases - ~\$1.2 Billion

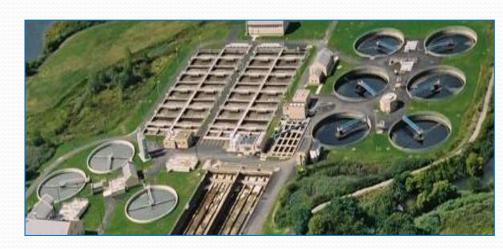
# Field's Point and Bucklin Point Seasonal (May - Oct) Average Effluent Total Nitrogen

#### **Bucklin Point**

- Initial upgrades completed in 2006
- 5 mg/L limit in effect July 2014

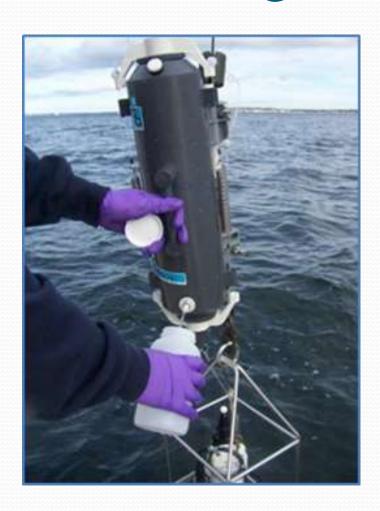
## NBC Nutrient Monitoring

- Total dissolved nitrogen, total nitrogen, and orthophosphate
- Dissolved inorganic nitrogen
   (DIN) = nitrite, nitrate, ammonia

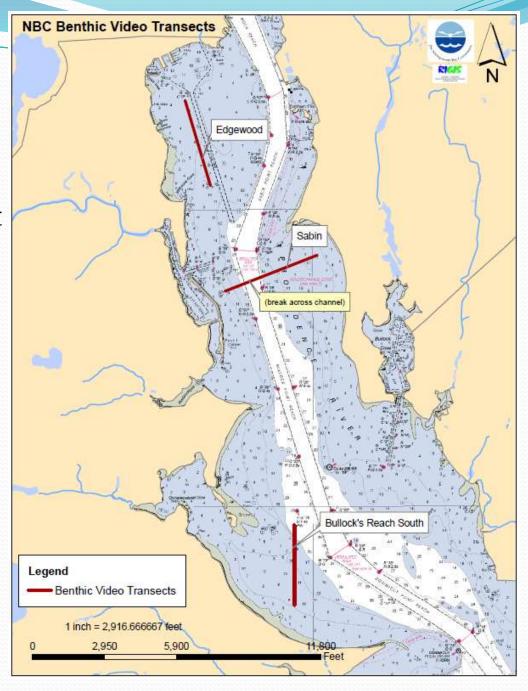
### **Benthic Video**

- Began in 2011; in earnest in 2014
- Goal note observable changes to benthos
- Underwater camera towed on custom sled
- Three "permanent" transects, ~1 km length each, ~1 hr footage each
- Attempt to survey monthly
